Navajo Abandoned Uranium Mine

Site Screen Report

Julia Semallie AUM Site

Weston Solutions, Inc.

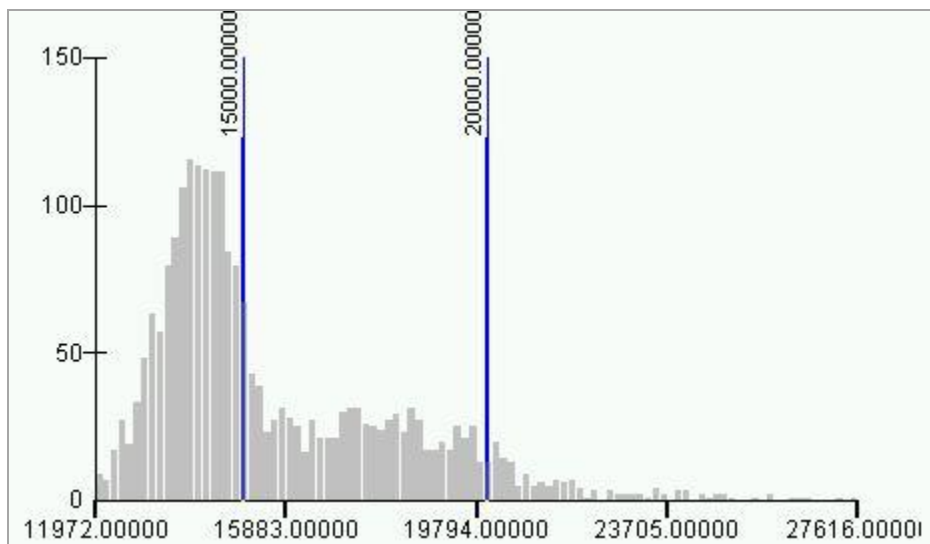
The following chart and statistics were generated by ESRI ArcGIS 9.3.1, and show the general distribution of the site gamma radiation measurements. The horizontal X axis represents the gamma radiation reading levels in cpm (lowest levels to the left). The vertical Y axis represents the frequency of each gamma radiation level.

Count:	2285
Minimum:	11972.00000
Maximum:	27616.00000
Sum:	35733720.00000
Mean:	15638.38950
Median:	14673.00000
Standard Deviation:	2514.94196

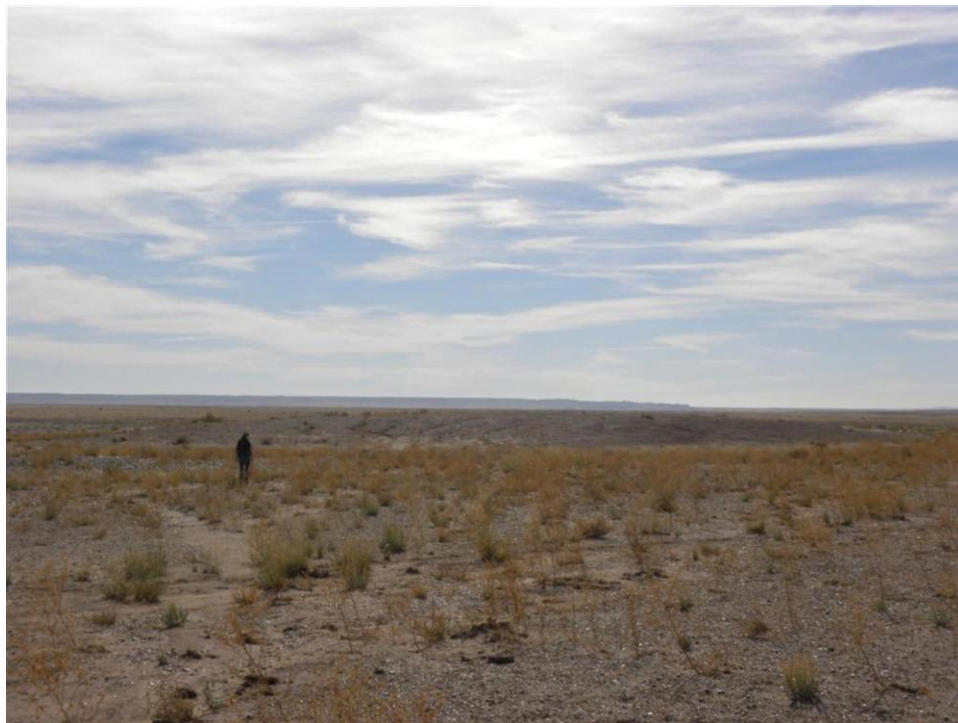
Photo 1. Julia Semallie mine site

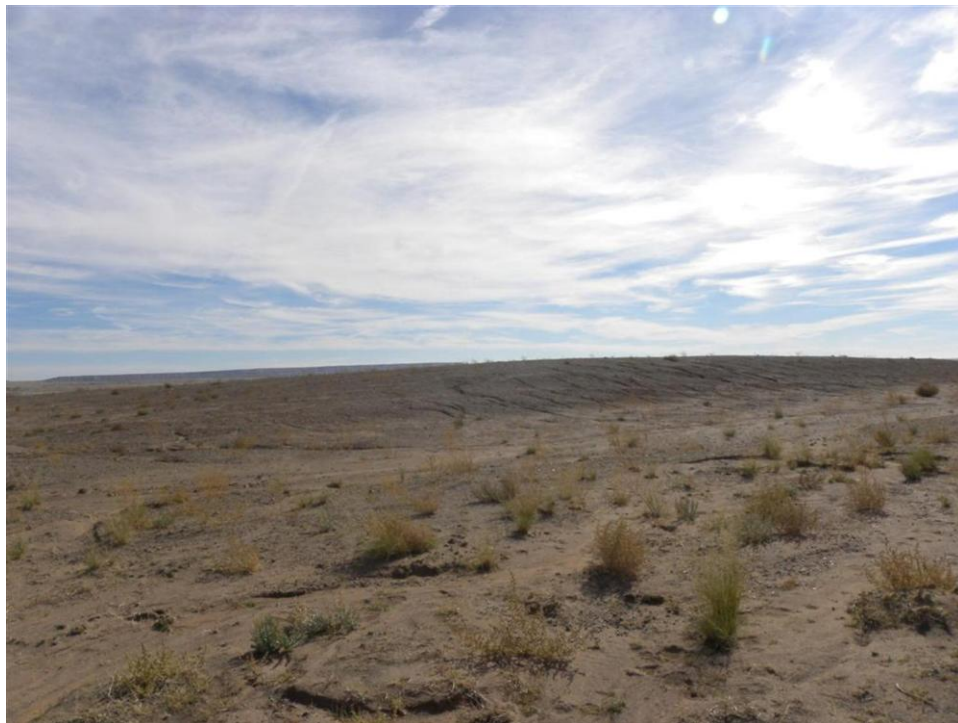
2 reclamation caps, shared with site #542: western cap 1000' x 300'; eastern cap 400' x 100', both made of grey material

Photo 2. Julia Semallie mine site, reclamation cap

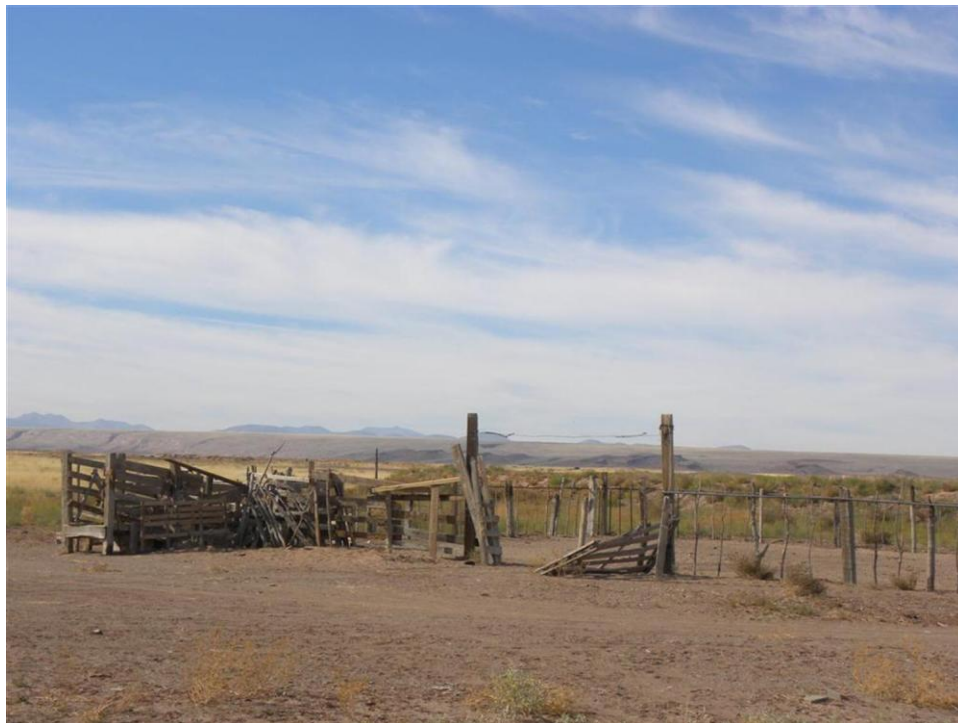
200 feet to 0.25 mile: Livestock corral used for cattle, approximately 500' SW of site

Background levels near corral

Photo 3. Julia Semallie, livestock corral 500' southwest of site

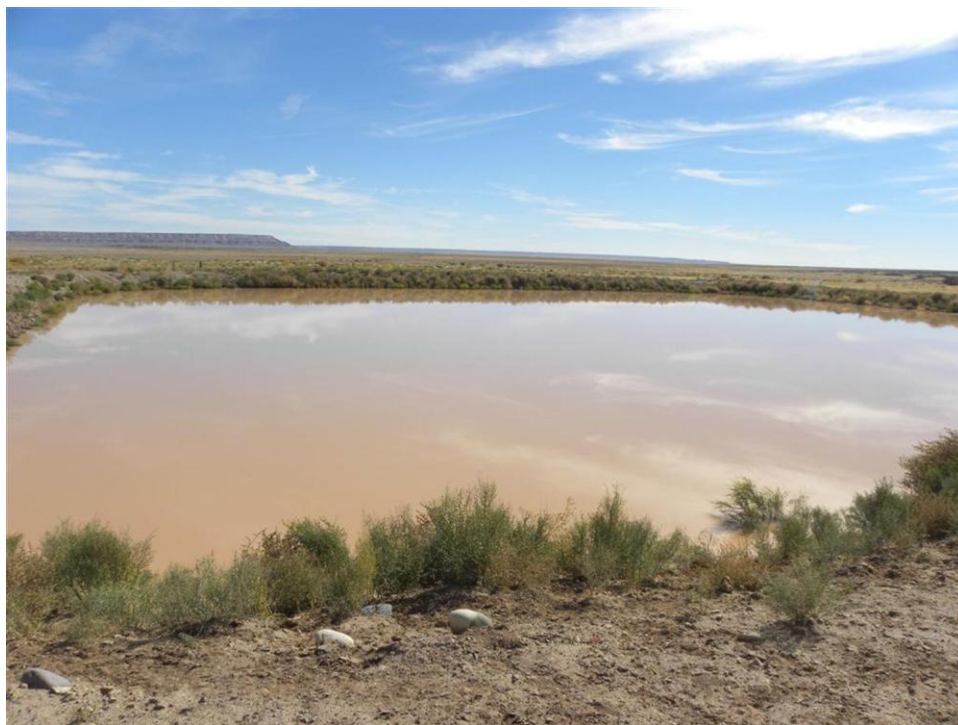
0 to 0.25 miles: Pond area behind livestock corral, approximately 750' SW of the site

Photo 4. Julia Semallie, livestock corral pond 750' southwest of site

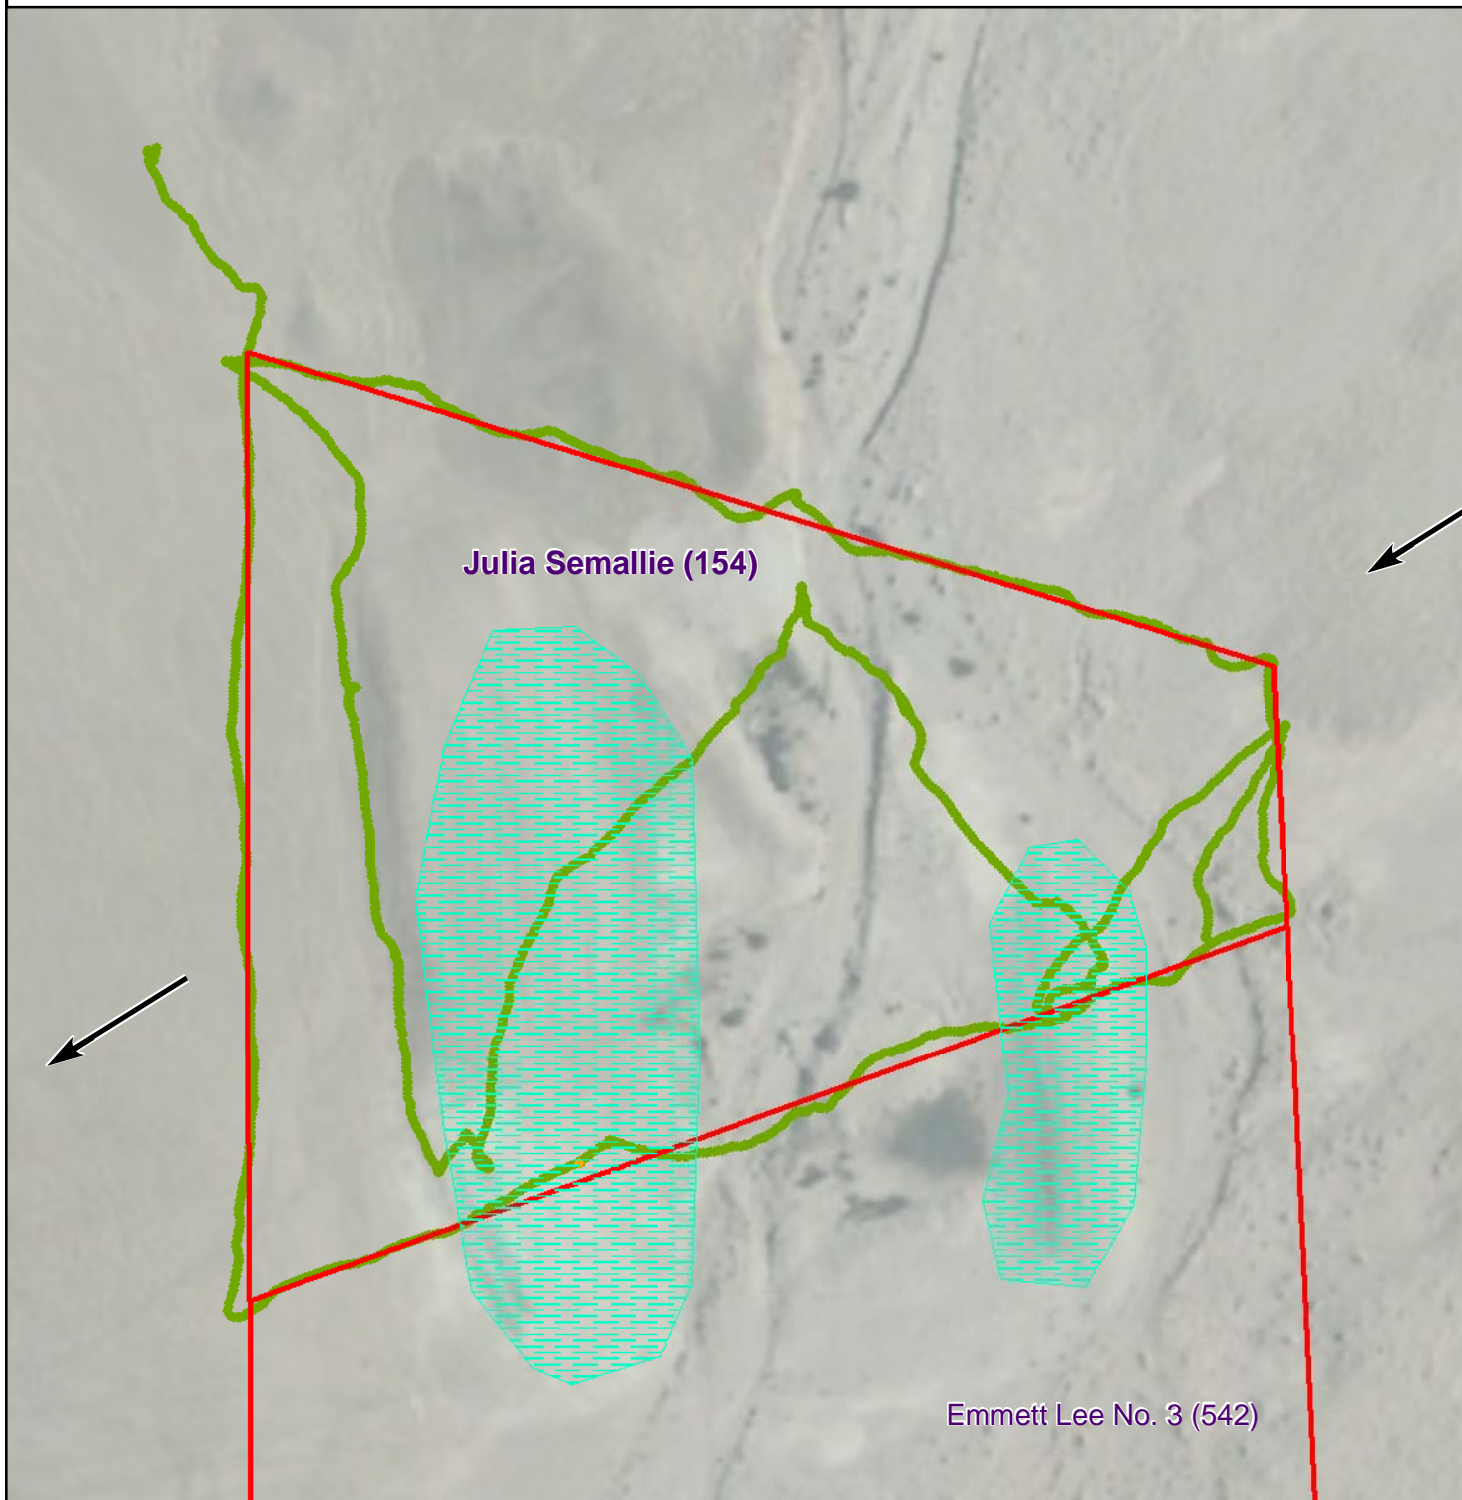
**Figure 1 - Gamma Radiation Measurements, Above Two Times Background
Julia Semallie (154)
Coalmine Mesa Chapter, Navajo Nation**

A total of 2,285 gamma radiation measurements were collected from the mine site, ranging from 11,972 cpm to 27,616 cpm. The measurements collected at the reclamation caps were found at a maximum level of approximately 25,000 cpm, and at background levels near the corral. The measurements are represented in Figures 1 and 2.

Gamma survey conducted 11/2010
Measured as counts per minute (cpm)

Average background 13,707 cpm

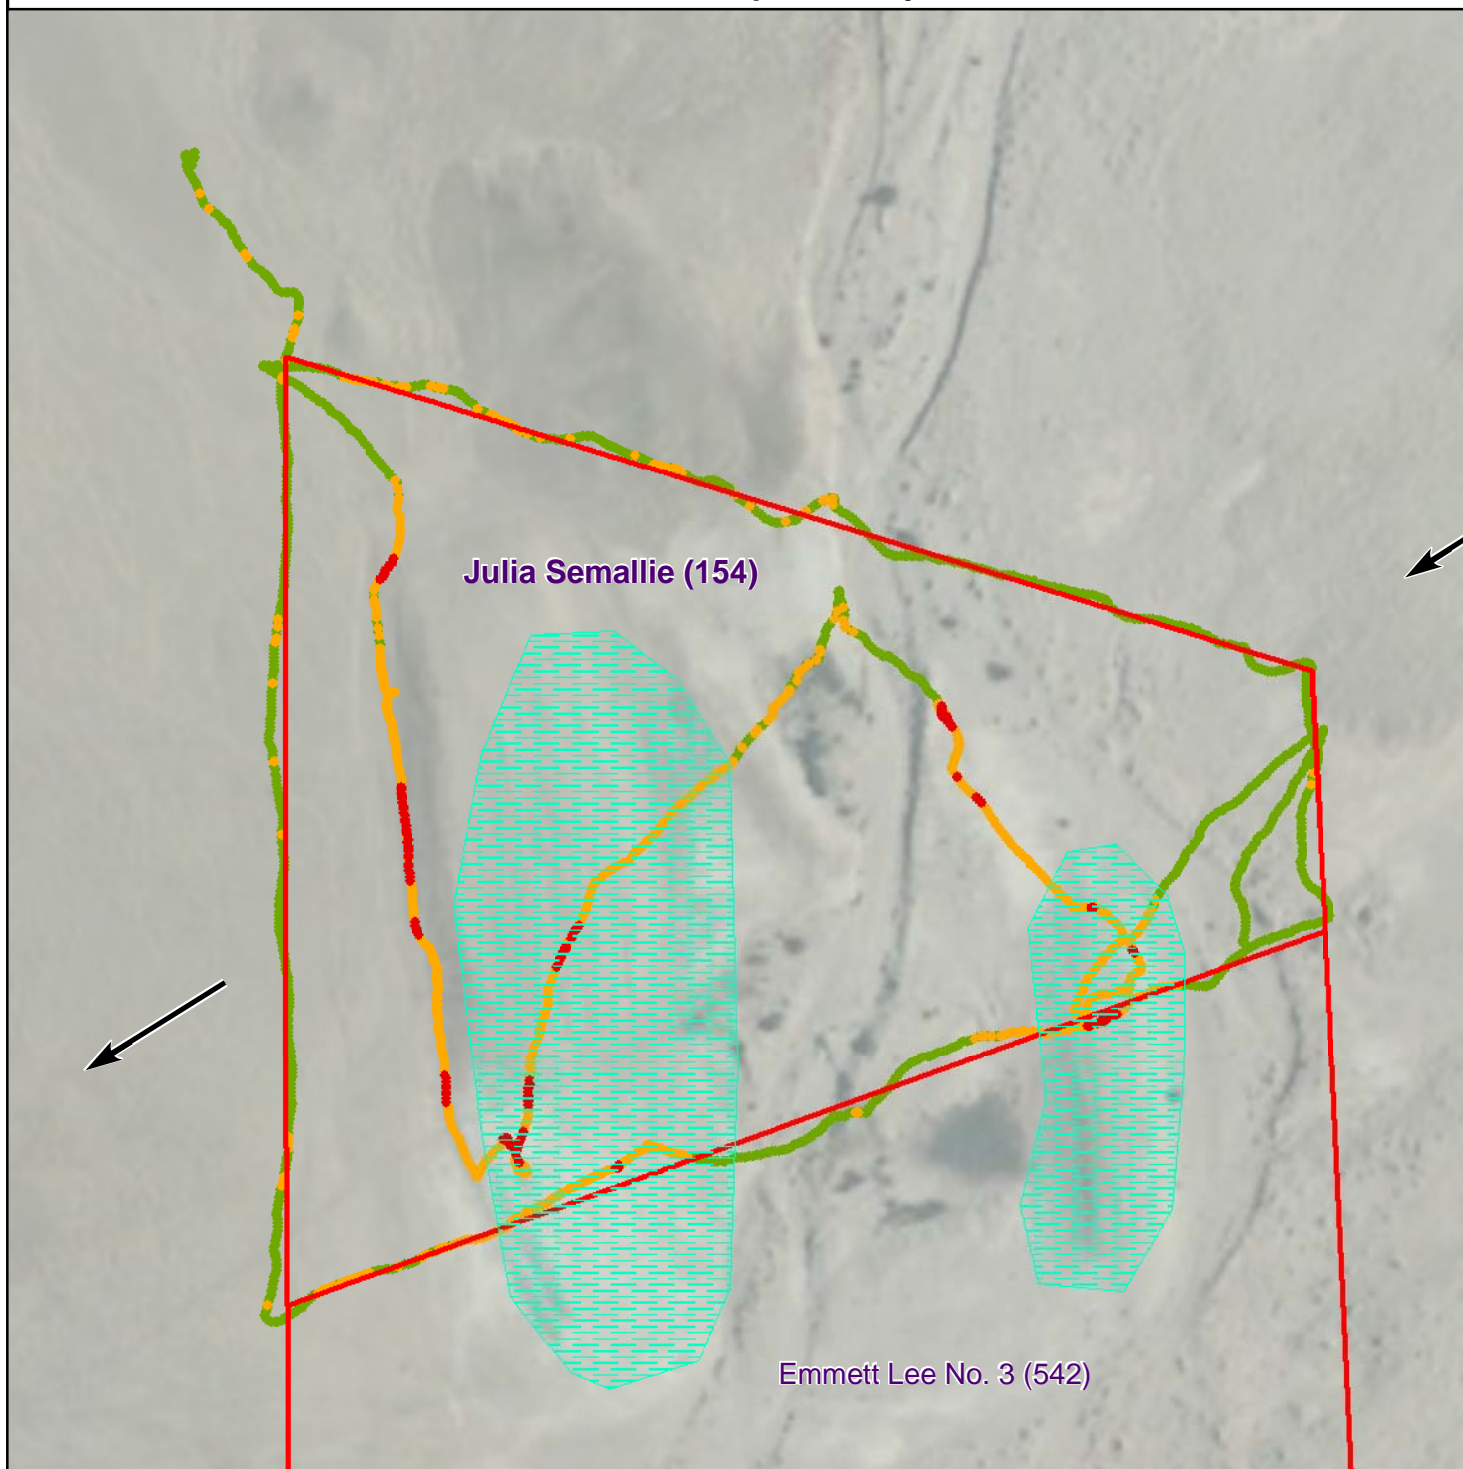
Figure 2 - Gamma Radiation Measurements
Julia Semallie (154)
Coalmine Mesa Chapter, Navajo Nation

Gamma survey conducted 11/2010
Measured as counts per minute (cpm)

Average background 13,707 cpm
